AWS Field Report 2017-18

Field Team: Carol Costanza, George Hademenos, Andy Kurth, Matthew Lazzara, Marian Mateling, and Dave Mikolajczyk

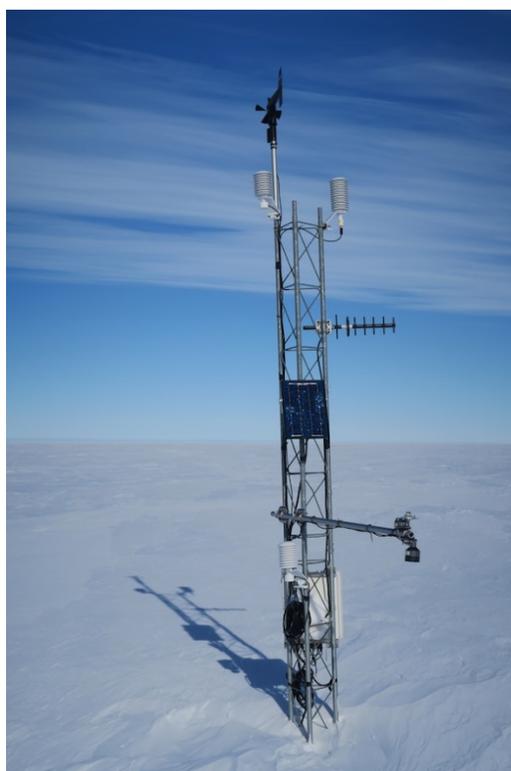
First, we found out that the datalogger clock is correct. Second, we tried to raise the power system, but there was too much ice. We even tried to take out one of the batteries, and it was still very stuck in the snow. Once we had about 20 minutes until we needed to leave, we decided to just plug all the power cables back in. We didn't get to confirm that the power connected properly, so that will need to be double checked when we go back.

LOR before

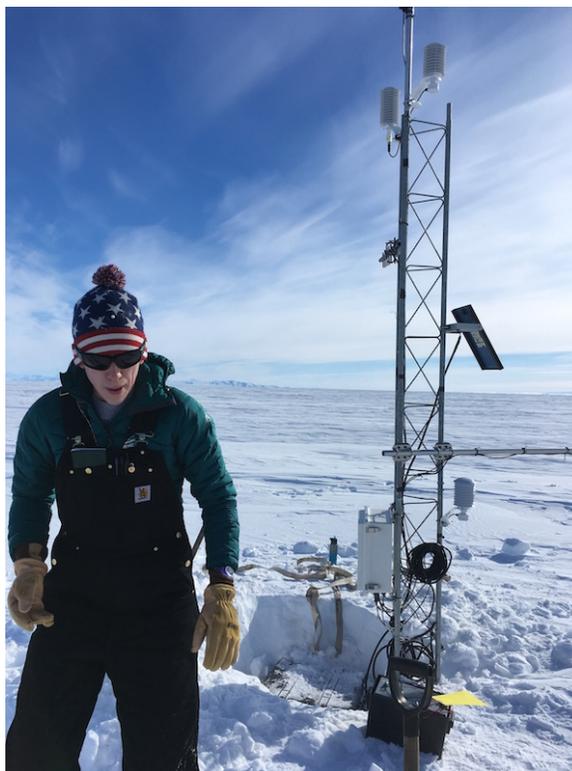
LOR after

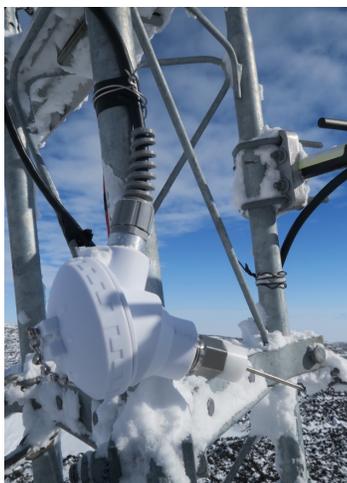
There was severe riming at Minna Bluff. All the snow / ice was removed as best as possible. We found that the temperature sensor at the top was missing its Gill shield. The temperature sensor was taped down with electrical tape and wire. The real-time data values were checked with the keypad (see pictures below). Finally, it was determined that the tower is leaning about 10°. Another visit will be needed to fix the temperature sensor, tower, and maybe the wind speed sensors.

MNB loose temp. sensor without a shield

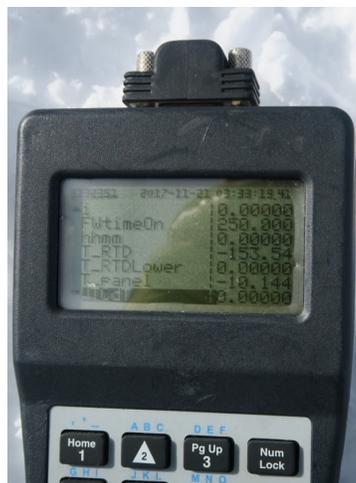
MNB temp. output of -153.54 °C

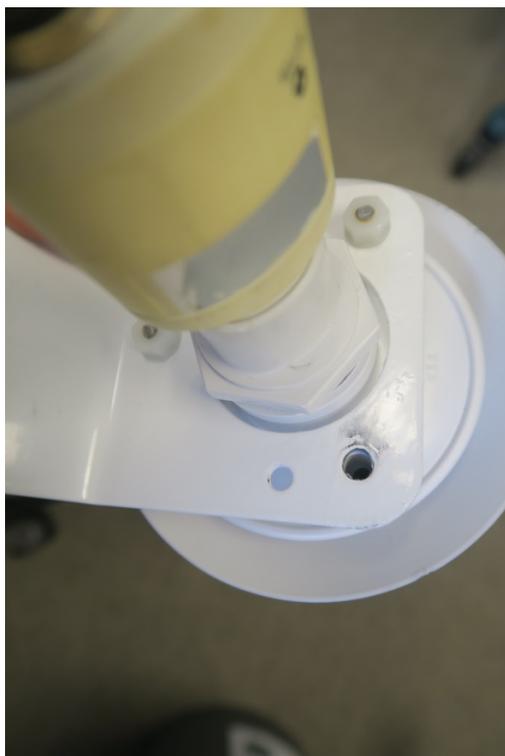
First, we had to carry all the equipment about 500 feet to the AWS from the groomed section of the road via 2 banana sleds. Upon arrival, we first installed the aerovane. Then we noticed an issue with the HMP since it's missing one of the bolts on the shield. We decided to not install the HMP since I knew we could drive back easily. Then we installed the rest of the instrumentation successfully. Finally, we plugged in all the cables and started to look at the keypad. All the values looked correct, so then we decided to insert a data card. Then the keypad showed that the data card was initializing table format or something similar for more than 5 minutes. We thought that the transmissions weren't sending, but it turns out they were working as of 00 UTC. Then we measured heights measurements for the sensors and took pictures.

PHX HMP

We will need to verify transmissions and fix the HMP shield on the next visit.

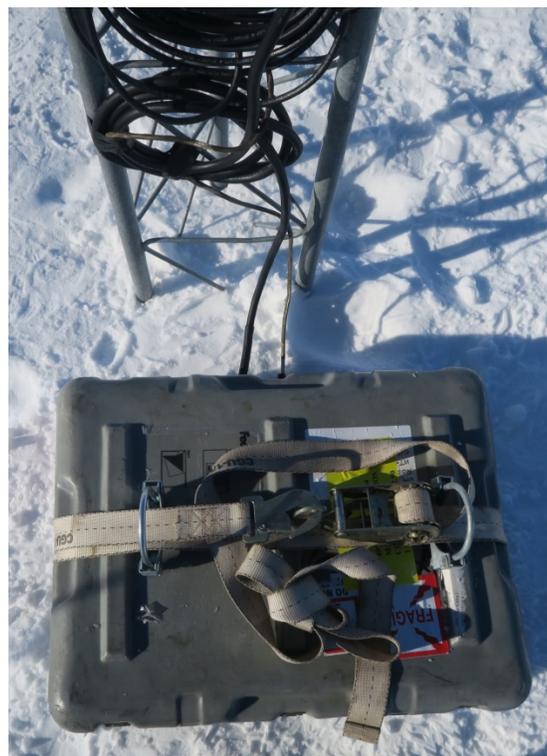
As we were putting the equipment in the truck to drive out to Phoenix, we cracked one of the plastic handles on the hardigg case for the power system. We got some help from Kevin from PASSCAL to fix it with a cargo strap and metal rings. It turns out that power system was not used because it was wired incorrectly and one of the batteries crack. There was a leak of battery acid inside the case.

PHX power system with a cargo strap

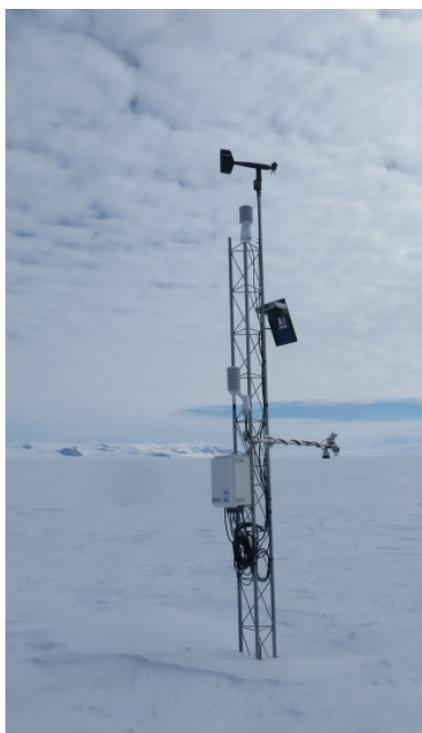
Swapped the data card and updated the CR1000 clock to current UTC time. The existing Vaisala pressure sensor had malfunctioned in early October 2017 and read a fairly consistent ~509 mb. We thought this was due to insufficient power and maybe a loose wire. We checked the wire continuity before rewiring anything, and the continuity for each wire was good between the datalogger and the sensor. After moving the power from SW12V to 12V, values still read ~509 mb, so we removed the sensor. A new one will need to be installed.

Linda AWS

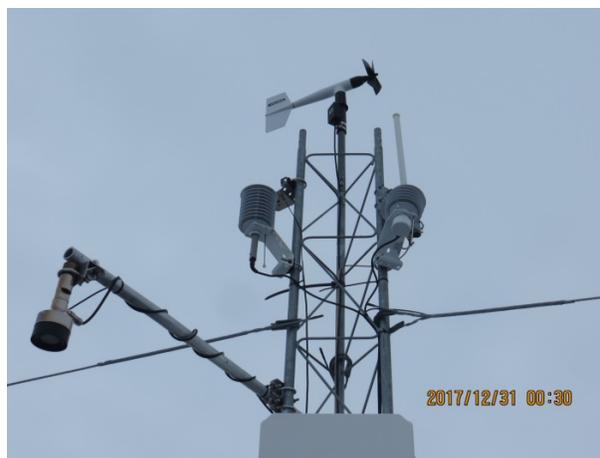
Upon reaching the AWS, the UNAVCO GPS unit was turned on. The radiation shields for the temperature and relative humidity sensors were each missing a long screw rod, and each had one of the rods loose and about to fall out. Dave Screwed the loose rods and secured one on the temperature sensor with tape, as it was missing its nut.

The radiation sensors missing a screw rod

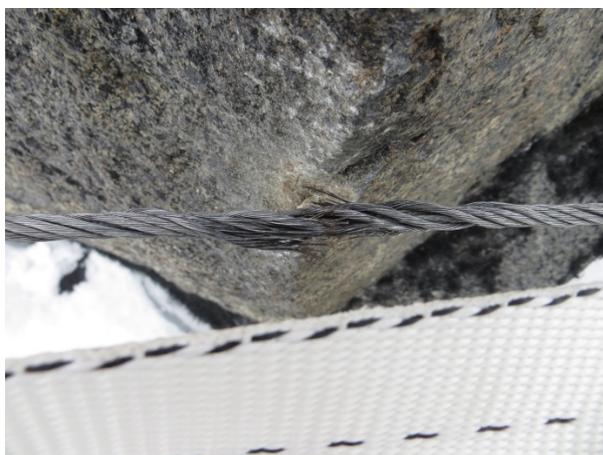
One of the three guy wires is getting worn down due to proximity to a large rock. In high wind events, the shaking of the guy wire is most likely causing it to rub against the

The worn guy wire

The cargo strap fix on the bad guy wire

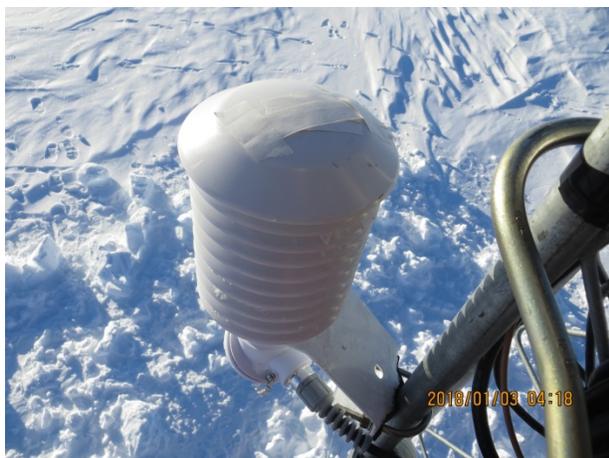
There was about 8 feet of accumulation in the two years since ATN was last visited (and installed). The snow surface was just below the enclosure, leaving the lower temperature and boom buried. We spent around 2 hours digging out the temperature, boom, and power system. The top of the lower temperature Gill radiation shield was damaged when digging down to recover it. It was repaired with some white tape and some pieces of the shield that were recovered.

The repairs to lower temp Gill shield

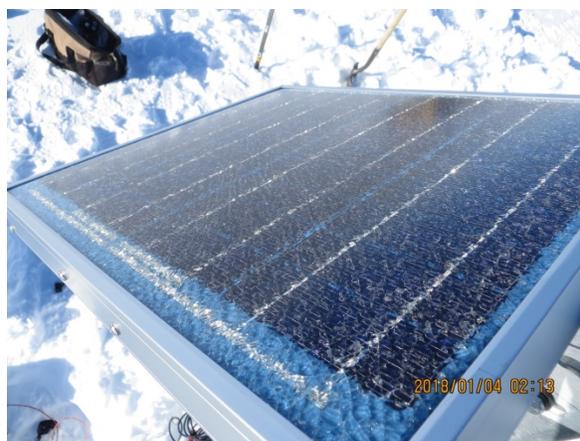
The snow temperature string instruments were not recovered (too buried). The solar panel appeared to be damaged, just on the surface, but still seems to be functioning properly.

Potential damage to the solar panel

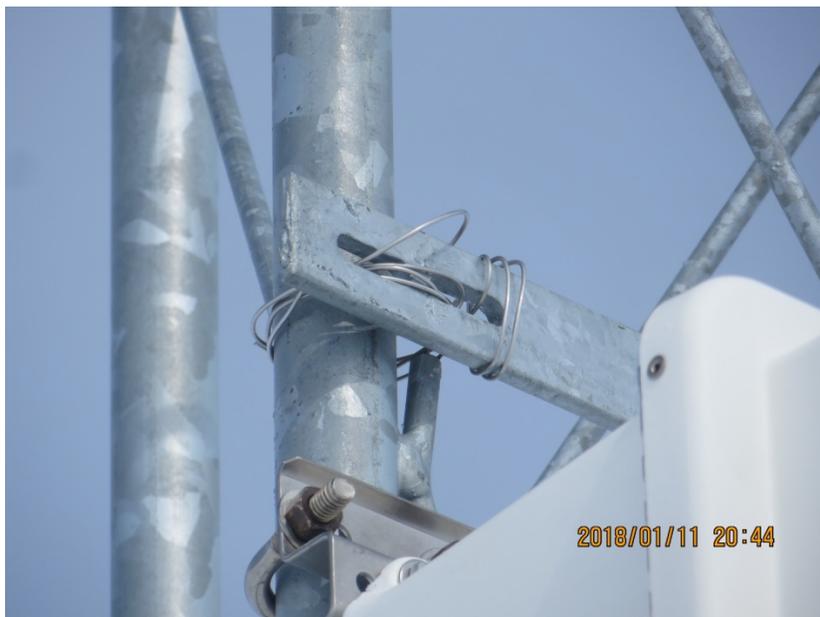
The antenna mount is missing a U-bolt.

Wire on antenna mount.

Retrieved solar panel and power cable and secured the antenna mount to the tower with wire, since a U-bolt is missing.

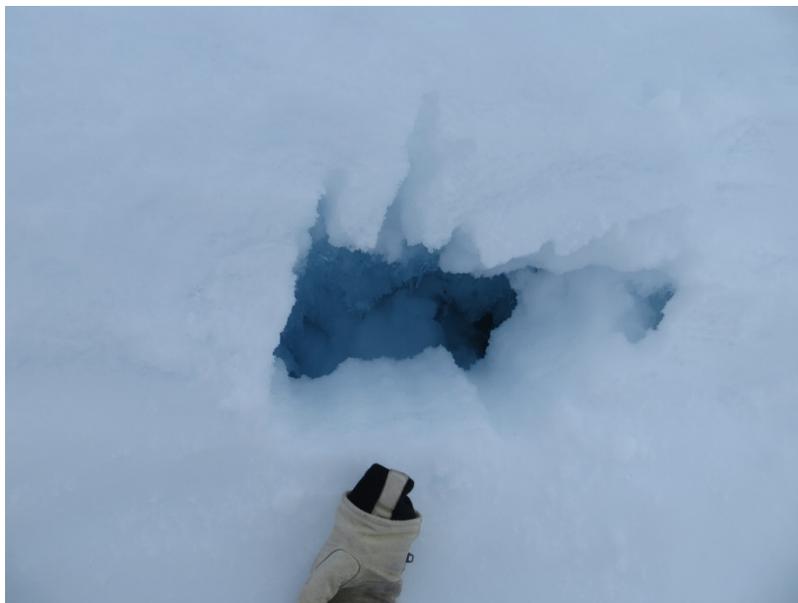
The crevasse (glove [size Medium] for scale)

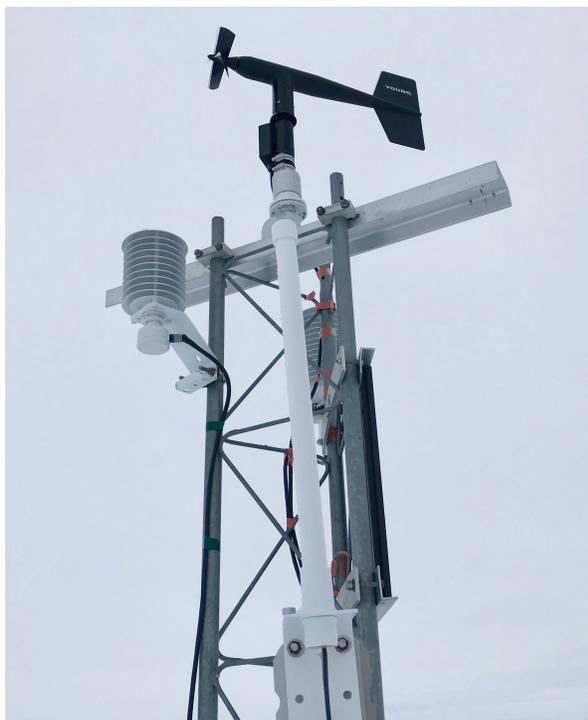
On January 5th, two temperature sensors randomly arrived at Cap Prud'Homme. They were sent from Wisconsin one year ago and were destined for D-10. After testing the sensors, Victor and I installed the sensors and a new datalogger program on January 15th. We also secured all the wires with new tape. All the sensors should be working properly now, but the station probably needs to be raised within the next few years.

D-10 new upper temperature sensor

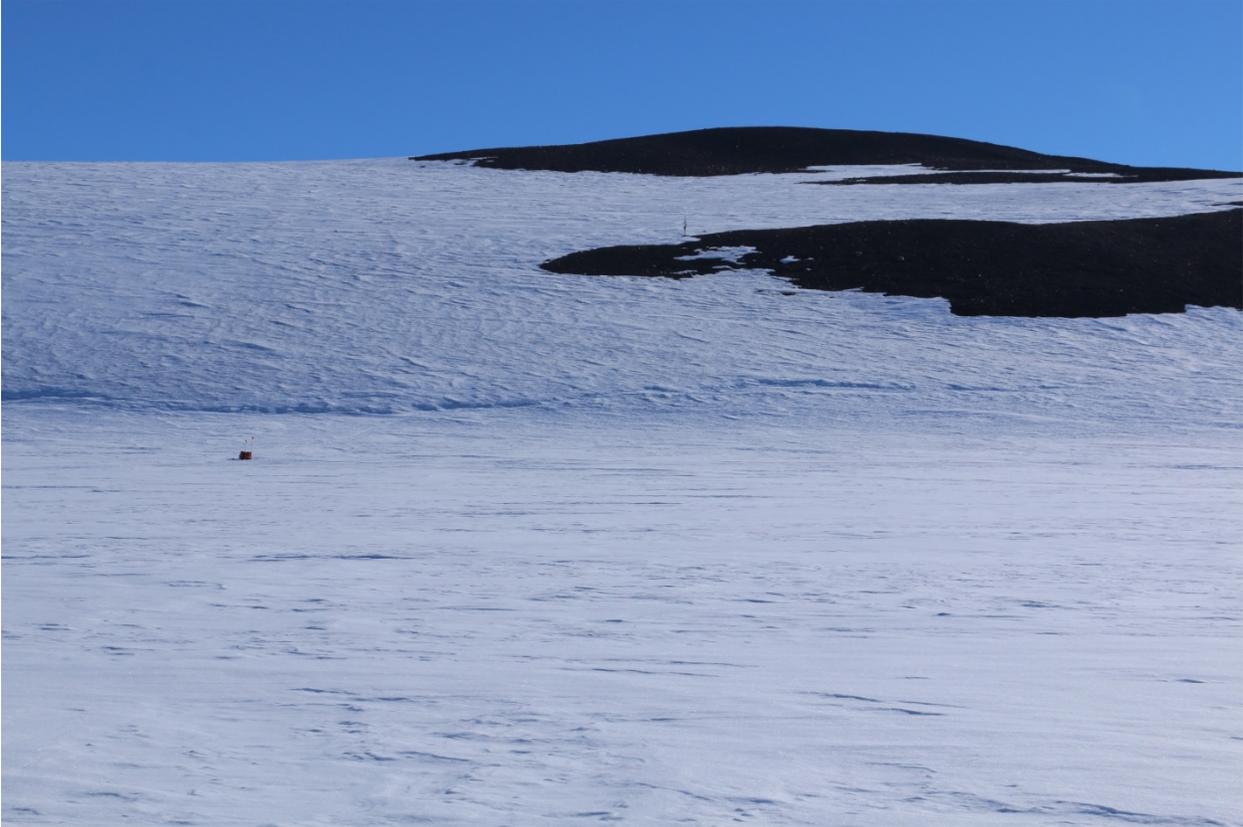
Back at WAIS, we talked with Mike Roberts (POLENET mountaineer) about surface conditions at Evans Knoll. He thinks that the crevasse that we were attempting to cross when we visited EKN on 01/13/18 is caused by a "bergschrund," or a crevasse that forms at the base of a hill, separating the snow and ice field on the hill and the glacier at the bottom. He estimates that the crevasse could be a meter wide in some parts. He thinks that the next time we visit, we should bring a mountaineer and have at minimum 3 people roped up (all with crevasse training) to climb up the hill to the AWS. One hypothesis is that the snow bridges covering the crevasse(s) melted this late in the summer season, so visiting earlier in the season may be better.

Evans Knoll. The fuel cache is on the lower left, with the AWS visible in the upper center. The bergschrund runs horizontally and is a little bit above the fuel cache on the hill.

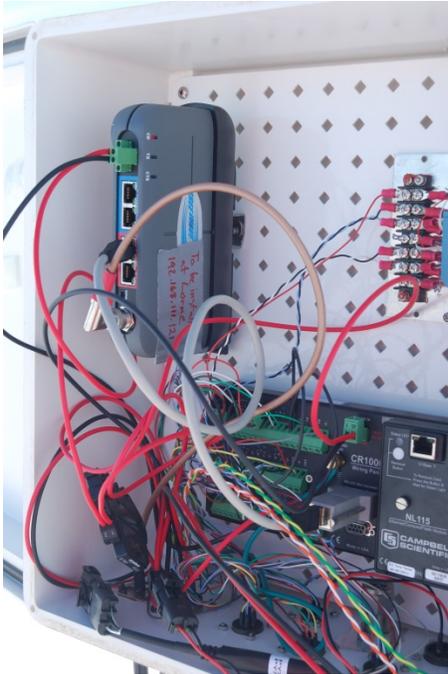
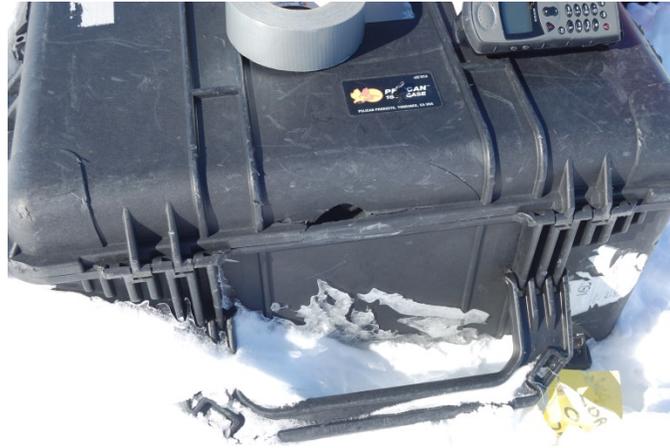
Lorne Electronics with new modem and battery box showing damage to the side seem.
