AWS Field Report 2017-18

Field Team: Carol Costanza, George Hademenos, Andy Kurth, Matthew Lazzara, Marian Mateling, and Dave Mikolajczyk

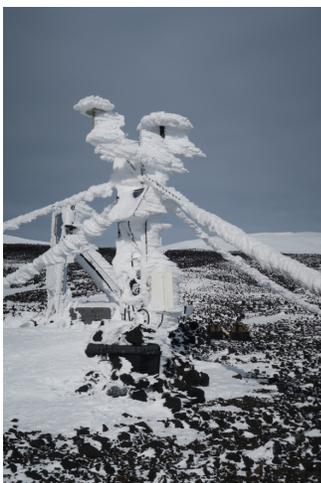
There was severe riming at Minna Bluff. All the snow / ice was removed as best as possible. We found that the temperature sensor at the top was missing its Gill shield. The temperature sensor was taped down with electrical tape and wire. The real-time data values were checked with the keypad (see pictures below). Finally, it was determined that the tower is leaning about 10°. Another visit will be needed to fix the temperature sensor, tower, and maybe the wind speed sensors.

MNB before

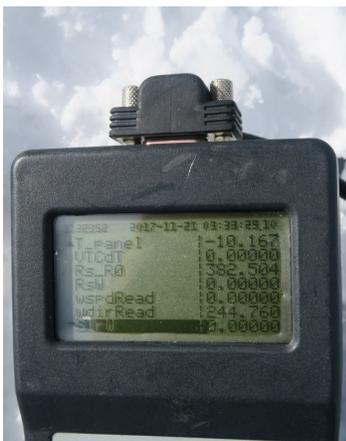
MNB wind direction 244.760° and wind speed of 0 m/s

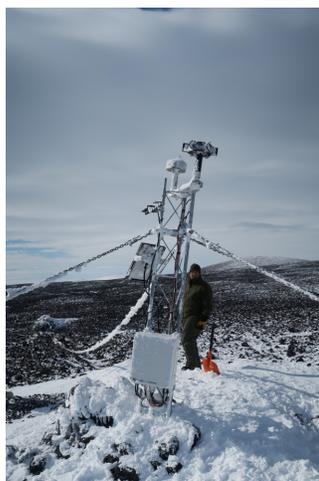
MNB after with a tilt of about 10°

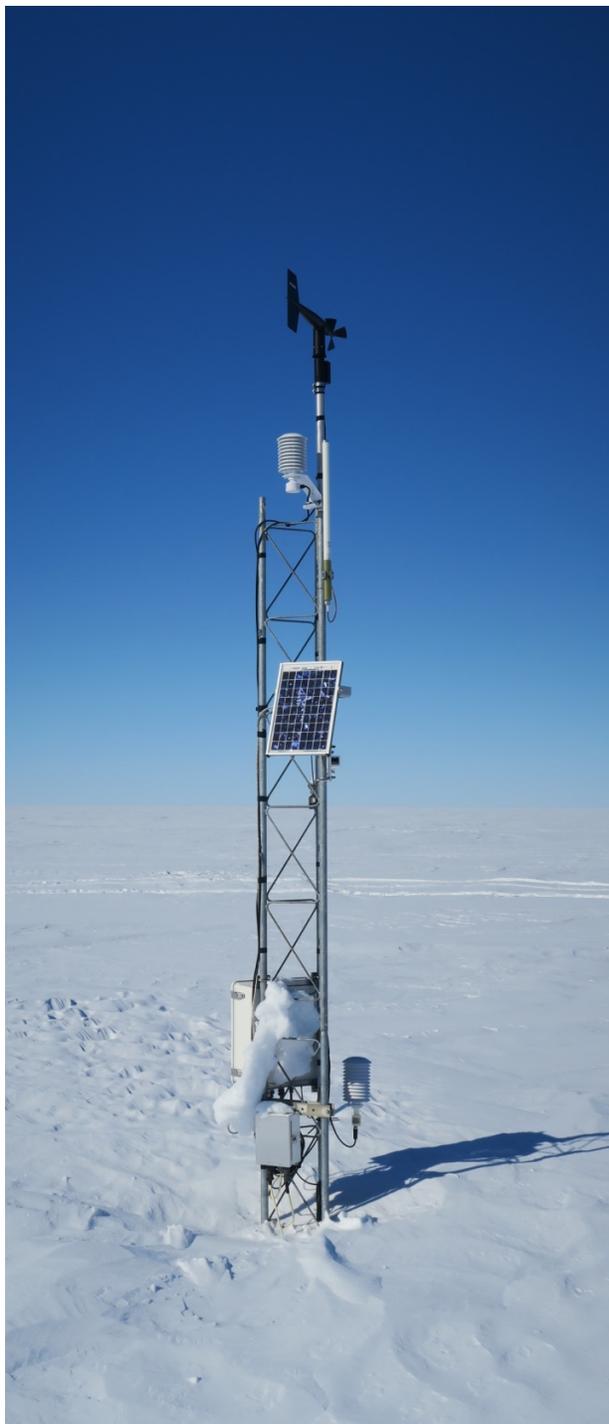
Gill before

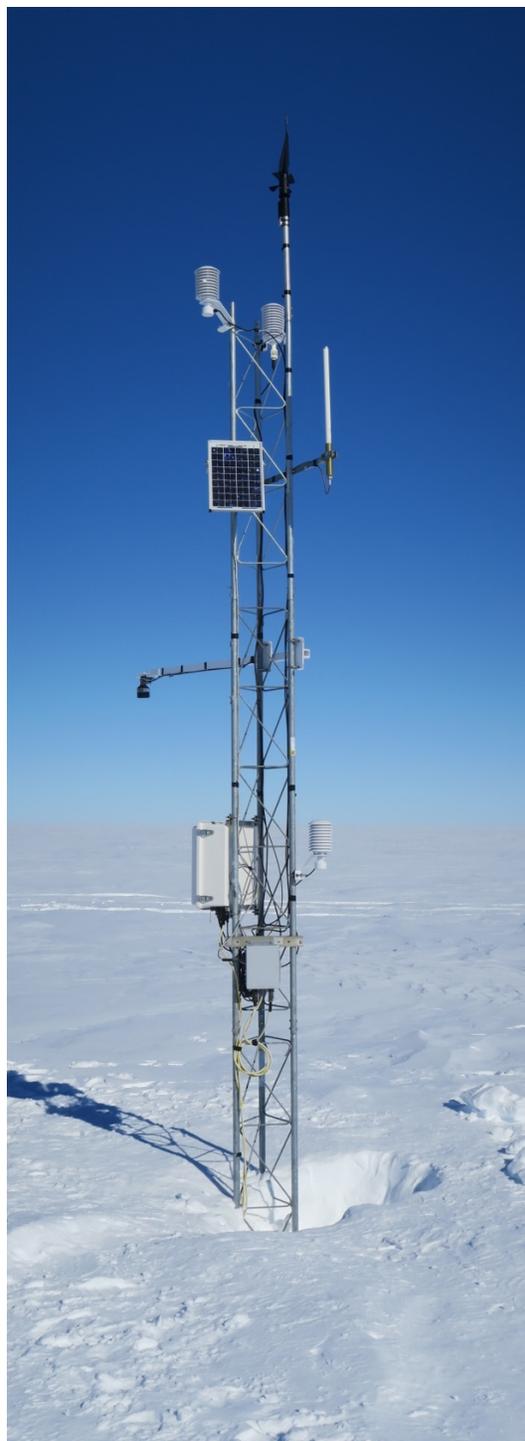
Gill after

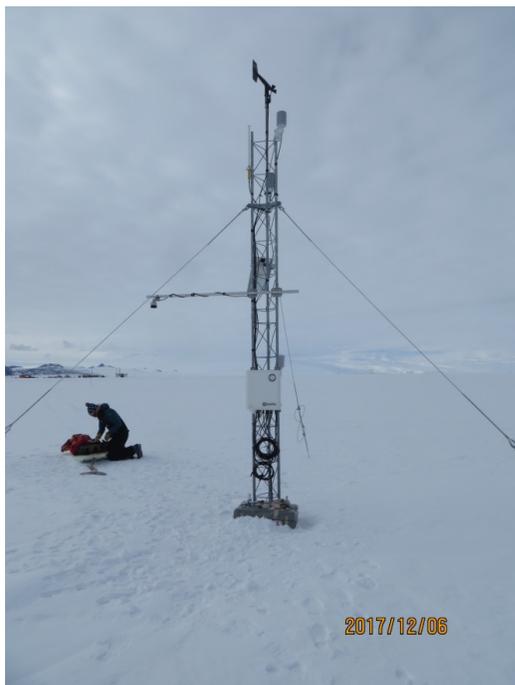
Phoenix AWS, after installing HMP

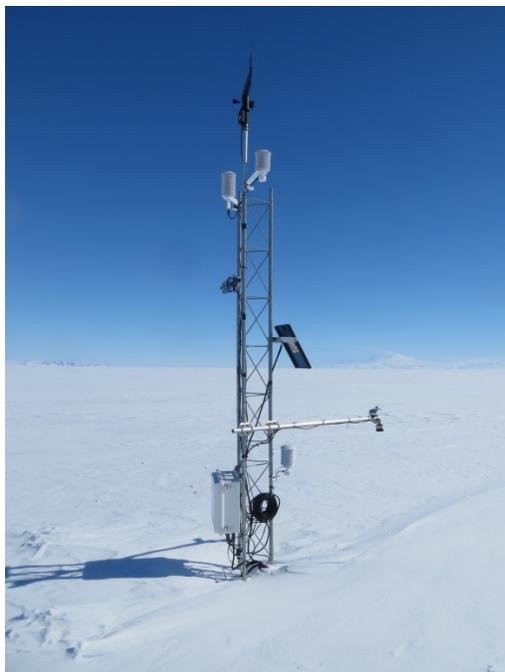
Lorne AWS upon arrival

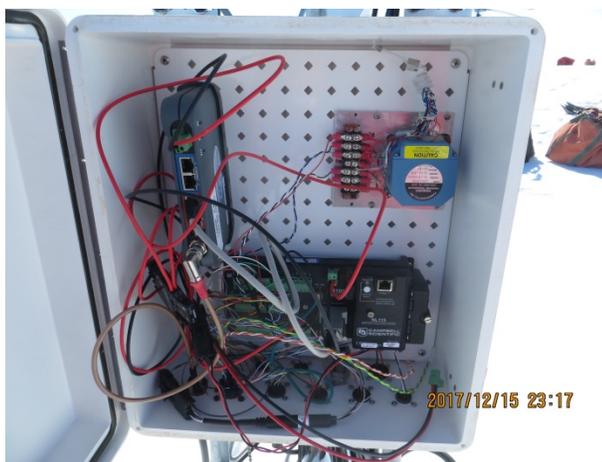
Inside LOR enclosure, before

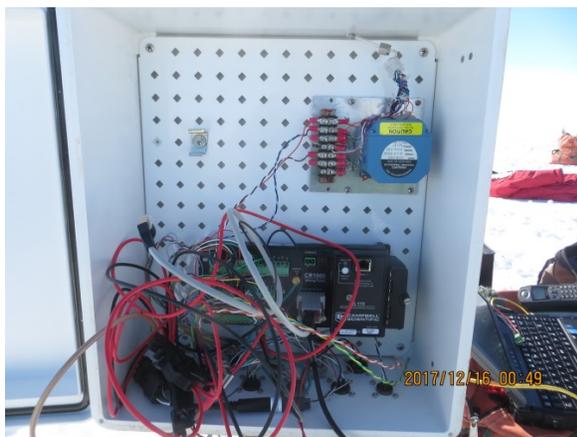
Inside LOR enclosure, after

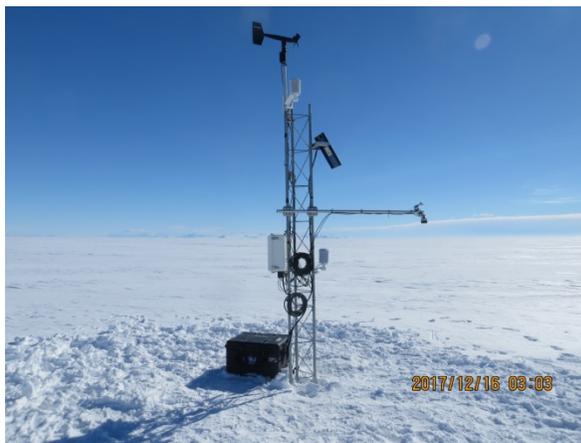
Lorne AWS, after

****NOTE****: LOR will need to be revisited to install a functioning Freewave modem

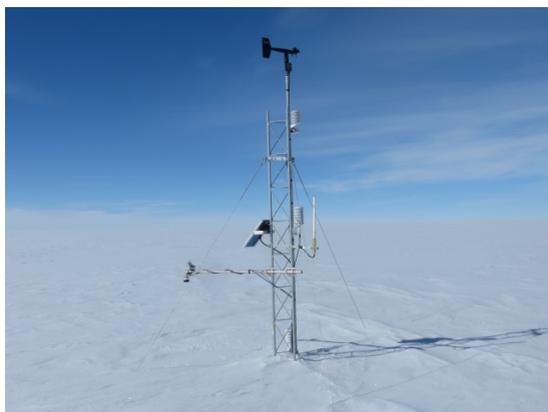
Kathie upon arrival

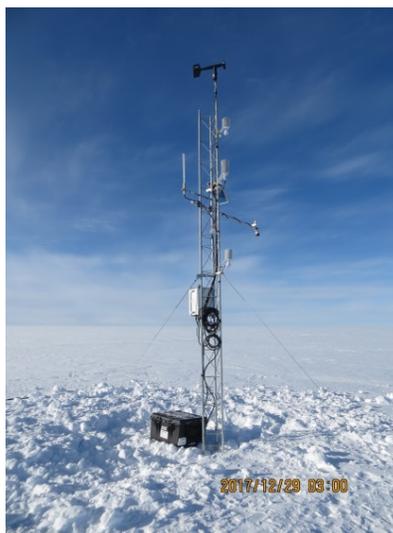
Kathie after

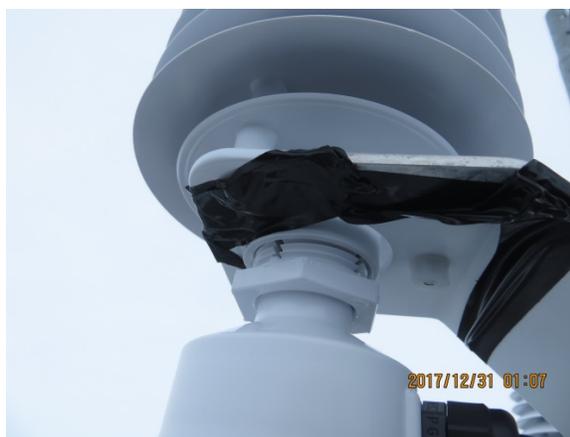
Upon reaching the AWS, the UNAVCO GPS unit was turned on. The radiation shields for the temperature and relative humidity sensors were each missing a long screw rod, and each had one of the rods loose and about to fall out. Dave Screwed the loose rods and secured one on the temperature sensor with tape, as it was missing its nut.

The tape job for the rod without a nut

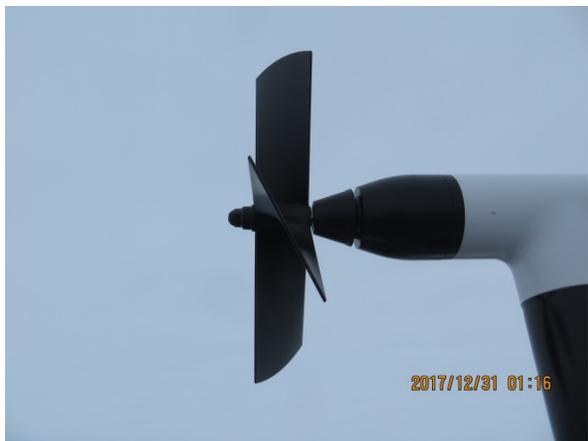
The anemometer is gritty when it turns. It is loose on the pipe it sits on, so the anemometer sensor can be lifted about half an inch before stopping. This indicates that the connection from the wiring to the potentiometer is loose, so wind direction measurements are incorrect. Dave and Marian did some spot checking of direction values, and they were way off with no evident offset. The propeller was about an eighth of an inch separated from the nose cone but seemed like it was still secure. Spot checking of wind speed values appeared to be OK. However, since the anemometer doesn't turn properly, all direction values should be considered incorrect and low wind speed values should be suspect since the anemometer may not be able to turn into the wind effectively.

The separation of the prop

****NOTE****: For next visit: pull program from data logger to laptop, install new guy wire and anchor (bring rock drill), install new radiation shields for temperature and RH, install new anemometer, possibly install new ADG.

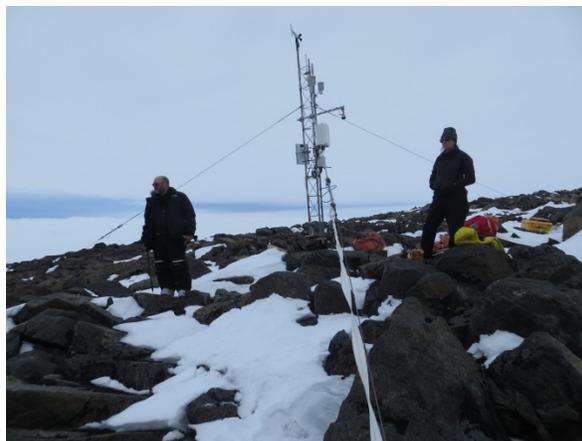
One of the three guy wires is getting worn down due to proximity to a large rock. In high wind events, the shaking of the guy wire is most likely causing it to rub against the

The cargo strap fix on the bad guy wire

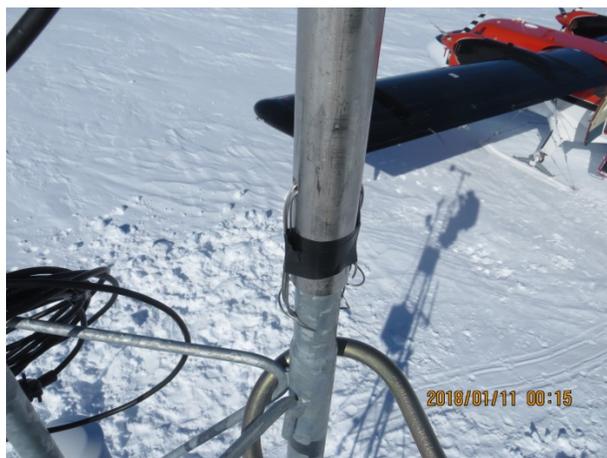
The anemometer pipe mounting.

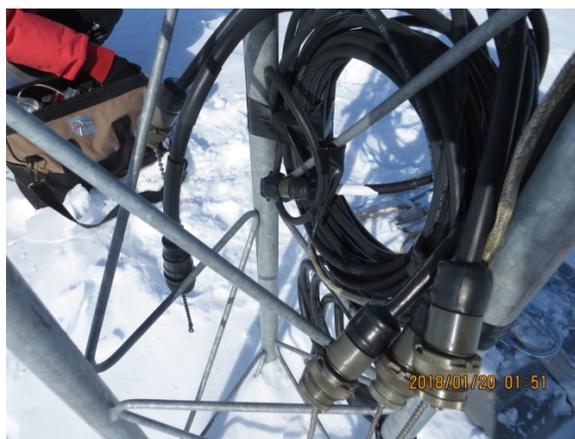
The cable spool. The lower T has white tape.

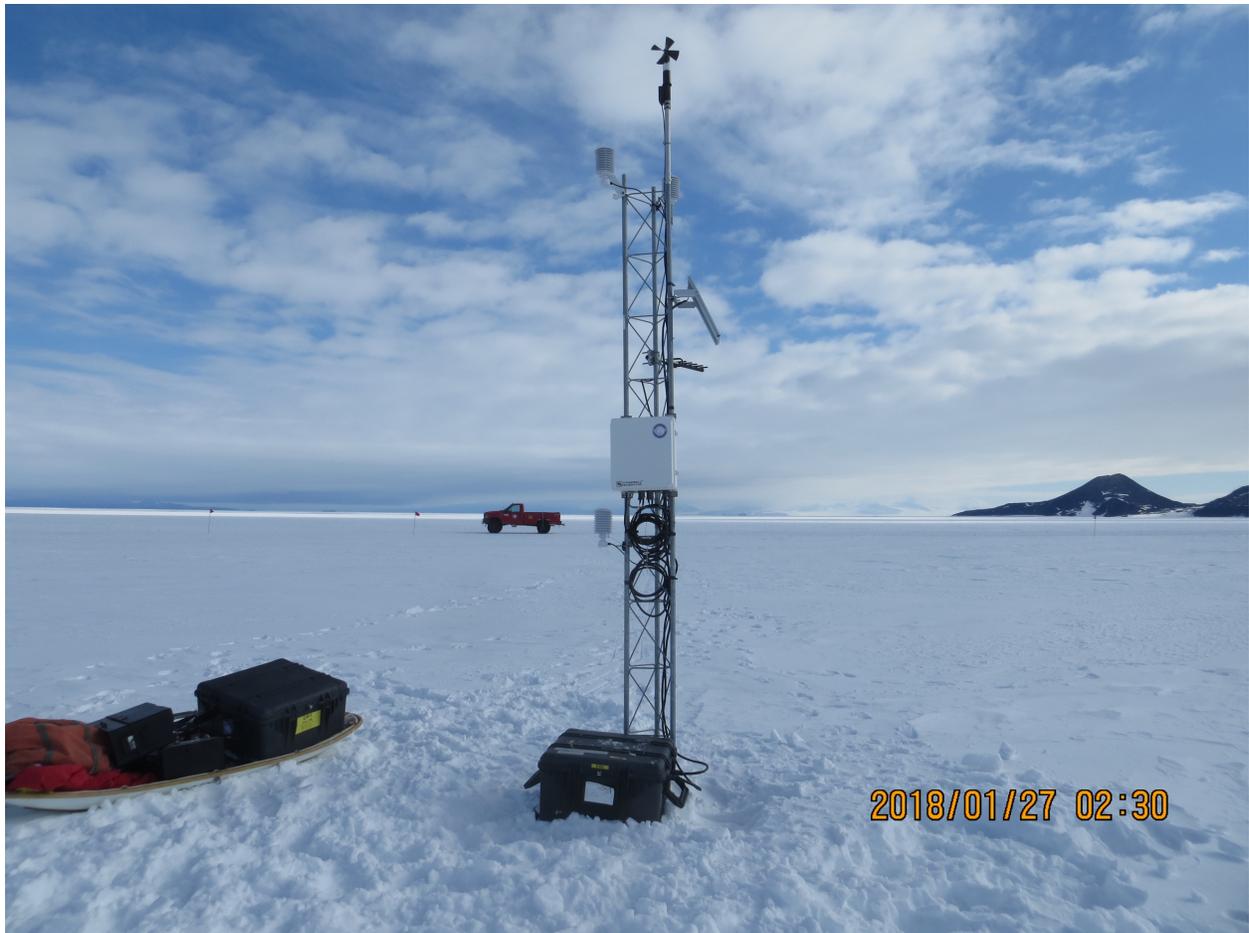
WFD after

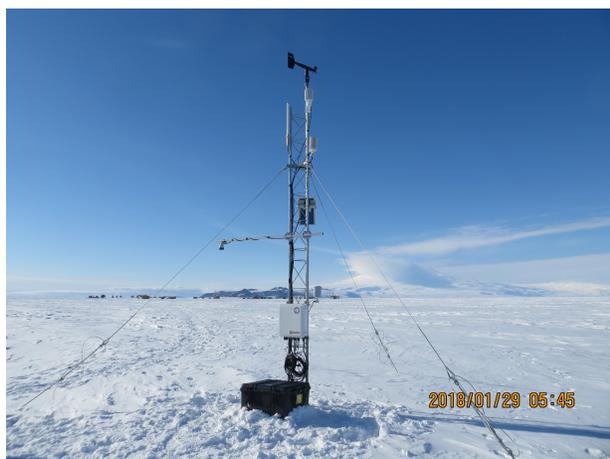
PHX after installing the power system, solar panel, and enclosure.

After testing the PHX Argos transmitter and CR1000 in the lab, it was found that the issue with the Argos transmissions was due to the PHX data logger. We reprogrammed the PGN data logger to be installed in the PHX enclosure.

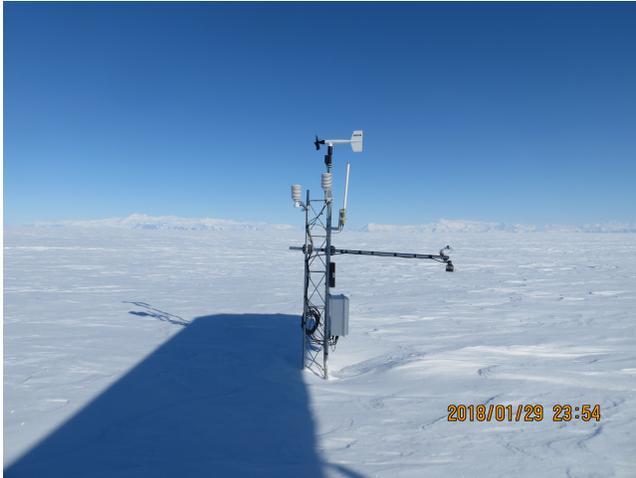
ELN upon arrival.

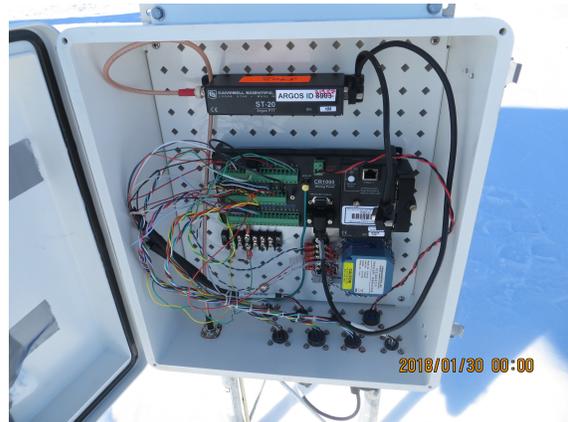
ELN enclosure upon arrival.

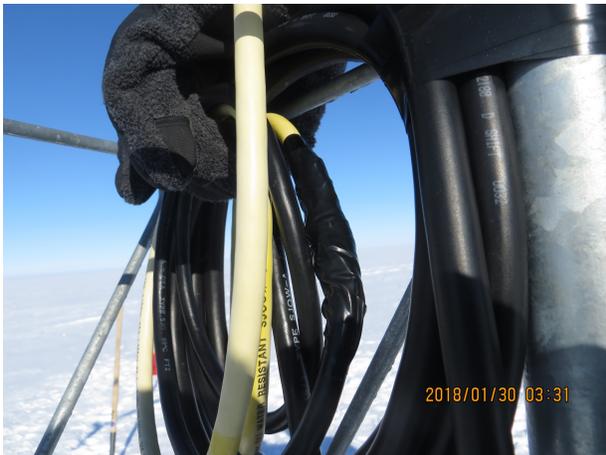
The spliced power cable.

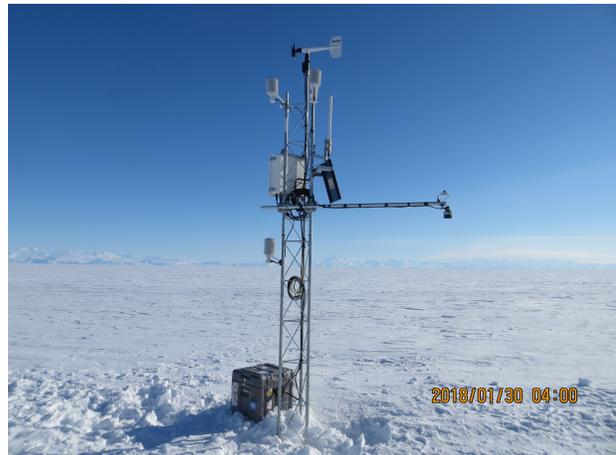
ELN after.

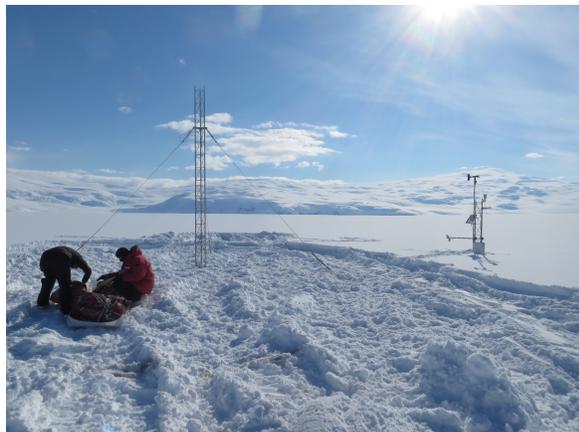
The new tower (left) and WDB (right).

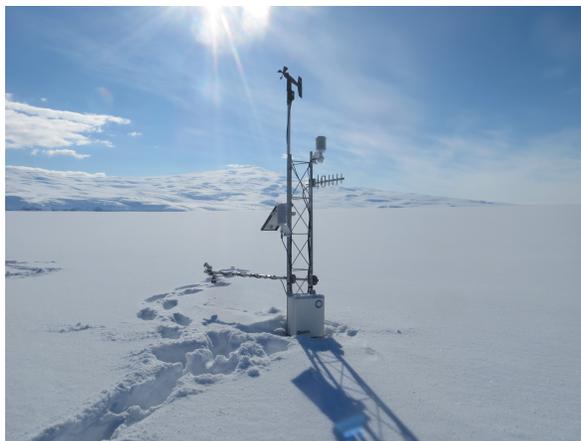
WDB upon arrival.

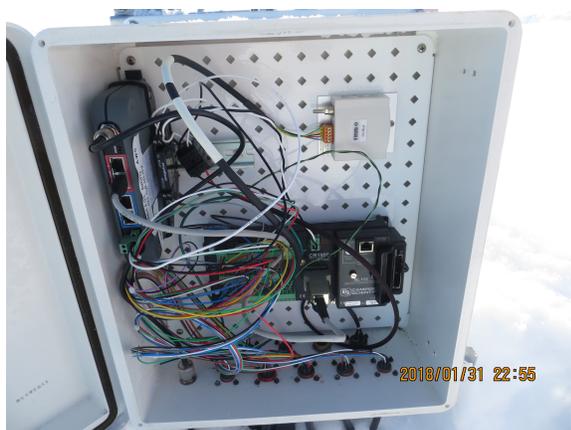
The UNAVCO GPS unit was set up for the duration of the visit. The program running on WDB is newawsFW31_WB.CR1. There was no data card present. It was discovered that the Compact Flash Module on the CR1000 was dysfunctional, as it could not read a data card. The CF Module was left at the site but should be considered to be replaced.

WDB enclosure.

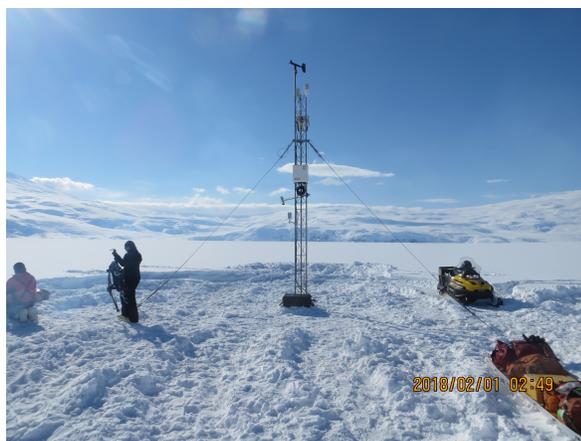
WDB after.

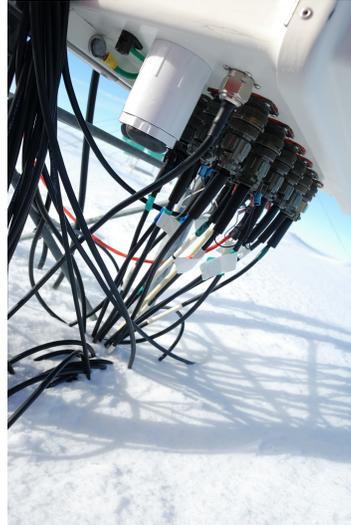
Bottom of enclosure

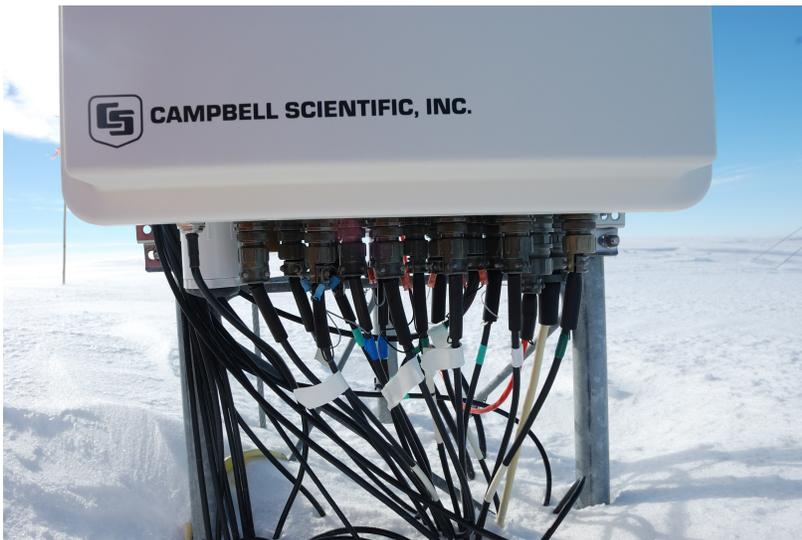
Another angle of the bottom of the enclosure

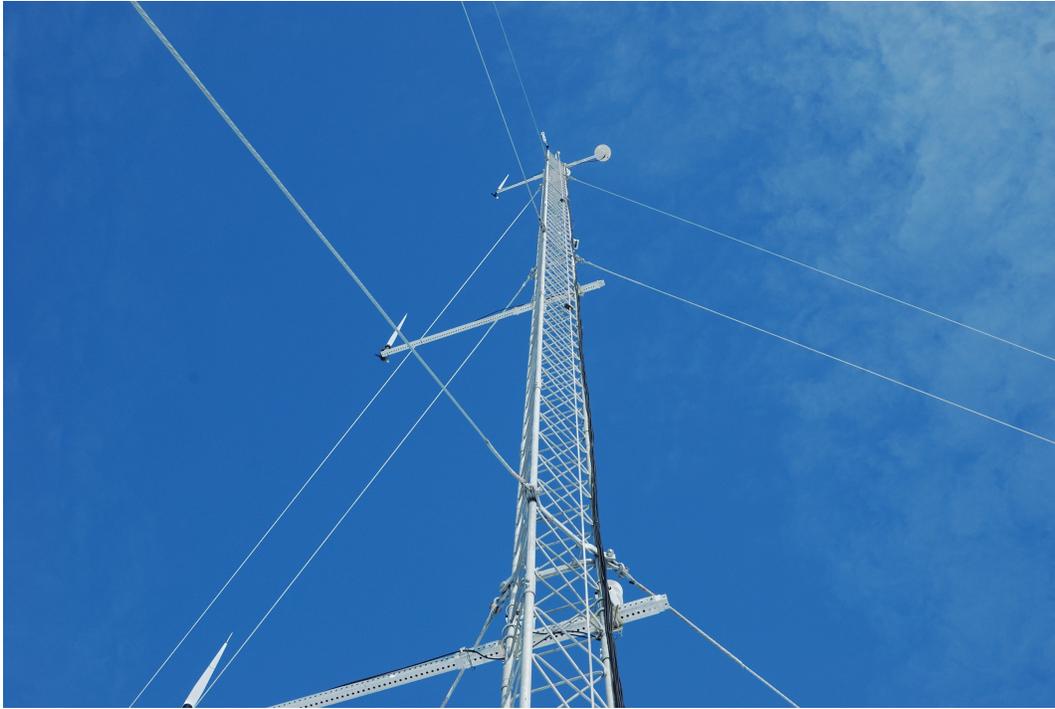
Top of BAT

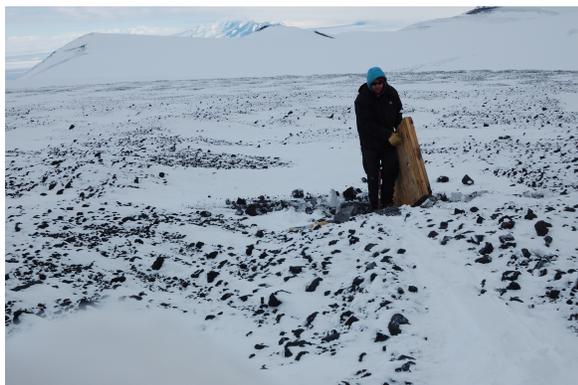
Bodie and one old deadman

NOTE: There are 5 old deadman that were recovered by the riggers. This equipment will NOT be able to fit in a 212, so a sling load will need to be prepared in order to get this old equipment sent back to McMurdo. This can be done by another group, like environmental, if needed.

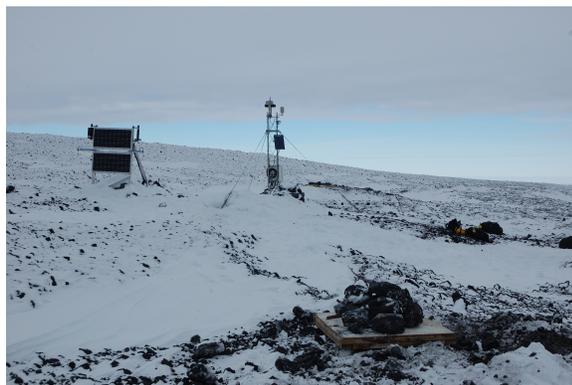
Lower right one set of equipment for deadman

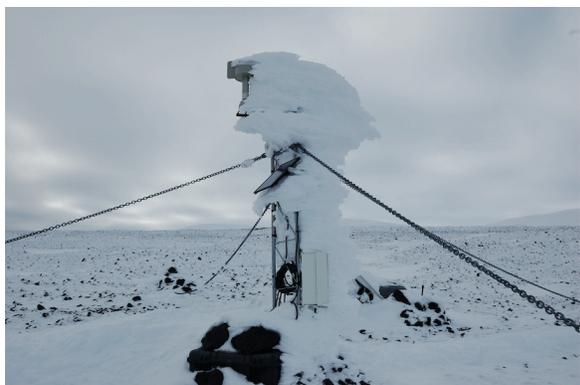
Minna Bluff upon arrive with Rime Ice

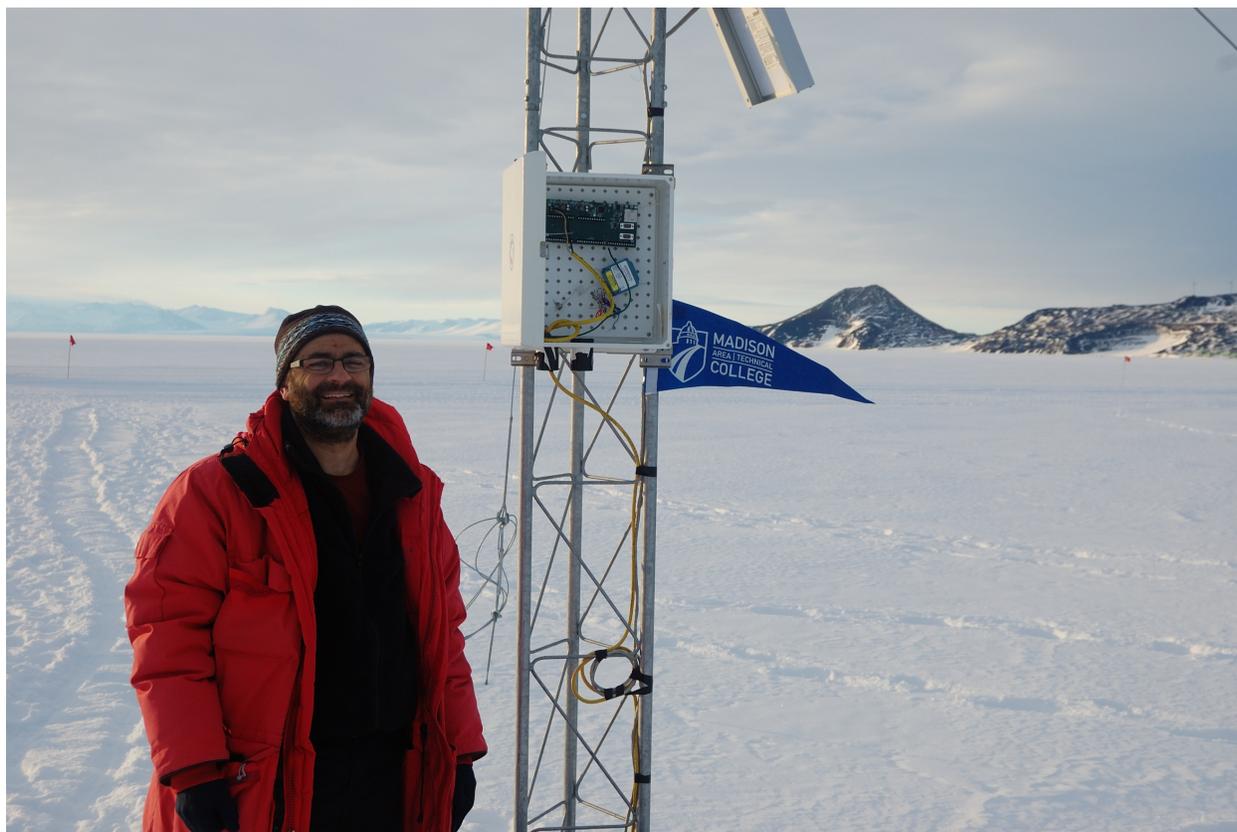
Prototype Madison College system installation at Willie Field.
